## Surface Chemistry of Ball Bearing Steels II

J.S. Murday and E.G. Shafrin

August 1978

NAVAL RESEARCH LABORATORY Washington, D.C.

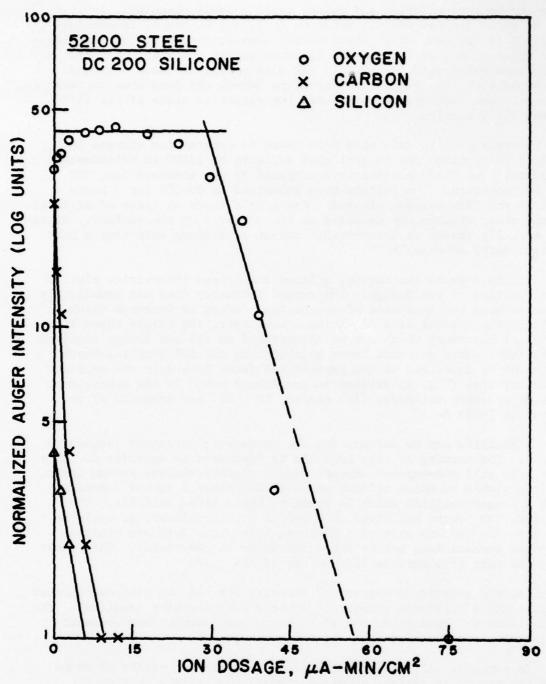
Figure 4 shows the carbon, silicon and oxygen intensities plotted as a function of ion dosage. The oxygen intensity does not immediately decrease upon the inception of sputtering. After an increase which reflects the removal of a contaminant overlayer, the oxygen shows a region of constancy which can be interpreted as the ion dosage required to sputter-remove an oxide layer thicker than the AES sampling depth. The point of intercept of the exponential decay line with the constant intensity line (Fig. 4) defines an ion dosage which is the approximate measure of oxide thickness (luA min/cm is  $\sim$  2Å, see Appendix A) reported in Table 8.

Fig. 4 - Auger/sputter depth profile of 52100 steel exposed for 3 hours at 25°C to DC-200, a polydimethyl siloxane. The TSC cleaning after exposure did not remove all evidence of silicon from this sample. A summary of this data is presented in Table 8, GD+DC-200 (2).

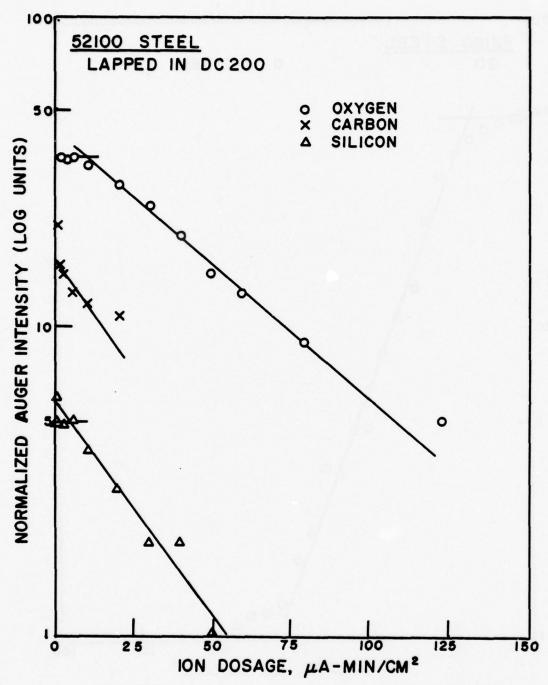
- (2) The lapping compound with DC-200 as a vehicle incorporated carbon and silicon into the oxide. This is reflected by the observation that the oxide thickness is smaller than the silicon decay time. In the previous section where the sample was simply exposed to silicone the silicon signal observed on the sample was shown to disappear prior to penetration of the oxide layer.

Fig. 7 - Auger/sputter profile of 52100 steel lapped with 3 micron  ${\rm A1}_2{\rm O}_3$  grit suspended in DC-200. Note the incorporation of silicon beyond the oxide layer.

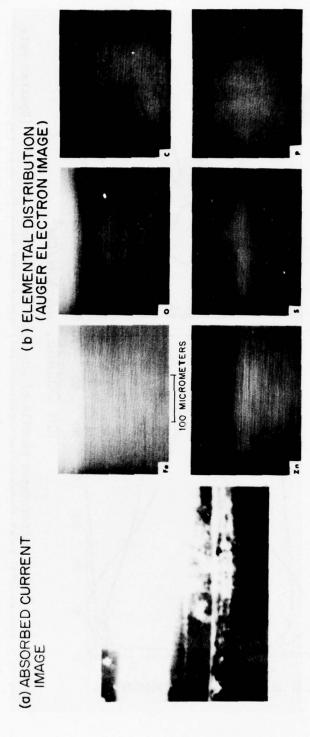
The scanning Auger micrographs shown in Figure 18 show that the distribution of Zn, P, S, and C is not homogeneous and that the wear track has a significantly different composition from the remainder of the ball groove. Sputter profile measurements of the composition in and next to the wear track provided the depth profiles presented in Fig. 19. In the wear track (Fig. 19a) the profile is similar to a solvent-cleaned 440C sample, with the exceptions of a thicker oxide layer, some phosphorus ( $\sim$  5 at %) and zinc ( $\sim$  2 at %) in the first few atomic

Fig. 18 - (a) Scanning-electron micrograph of an inner race from a disassembled bearing, No. 801. The bright horizontal band in the top of the micrograph locates the wear track. (b) The six micrographs on the right show a scanning Auger measurement of the elemental distribution of Fe, 0, C, Zn, S, and P about a point on the edge of the wear track; the lower third is well below the wear track.

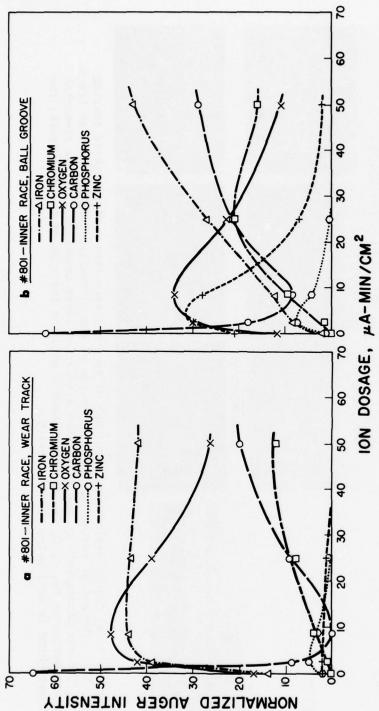
Fig. 19 - Auggr sputter-depth profile of the inner race shown in Fig. 18. [Sputter rate  $\sim 2 \text{ A/}(\mu\text{A/cm}^2)$ .] (a) Composition observed at a point well into the wear track corresponding roughly to the upper portion of the pictures in Fig. 18(b). (b) Composition observed at a point below the wear track corresponding roughly to the lower portion of the picture in Fig. 18(b).

layers, and a monolayer of carbonaceous material covering that. The thicker oxide is probably due to the mechanical stresses imposed by the ball or shadowing of the ion beam etchant by greater surface roughness. In the few layers with phosphorus the Auger lineshape is consistent with an oxygen phosphorus moiety.

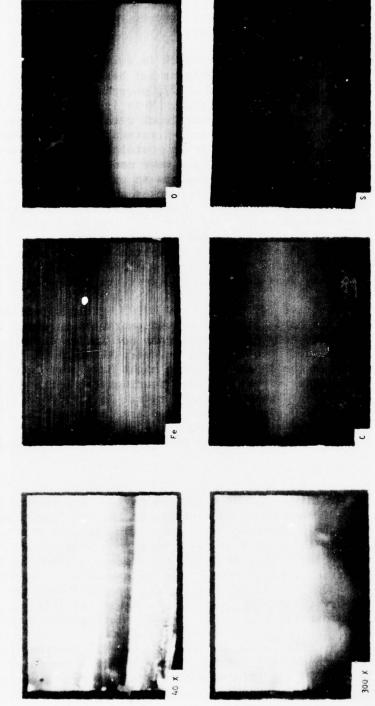
Fig. 20 - (a) Scanning-electron micrographs of a inner race from a disassembled bearing, No. M999B. The bright band at the top of the lower micrograph (300X) corresponds to the wear track. (b) These four micrographs show the scanning Auger measurement of the elemental distribution of Fe, O, C, and S for the same area as shown in the 300X SEM micrograph.

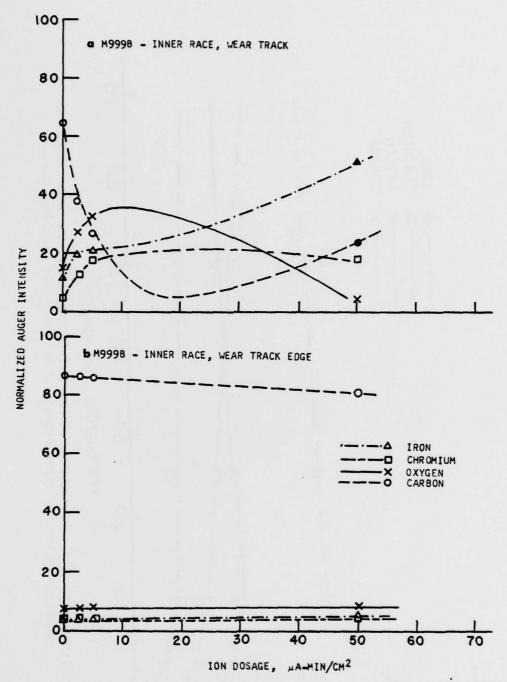
Fig. 21 - Auger/sputter depth profiles of the inner race shown in Fig. 20. [Sputter rate  $\sim$  2 Å/( $\mu$ A min/cm<sup>2</sup>).] (a) Composition observed in the wear track. (b) Composition observed at a point just below the wear track.

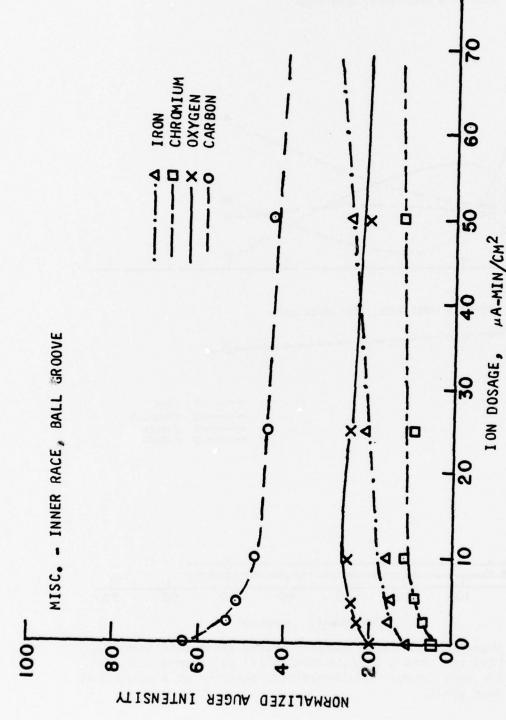
Fig. 22- Auger/sputter depth profile of the ball groove of an inner race which was rejected for use by Draper because it failed an oil spreading test.

by the observation of some substrate material even prior to sputtering. Those areas which are covered, however, have a fairly thick layer. The miscellaneous parts failed their lubricant wetting/spreading test; this layer may be the cause of that failure.

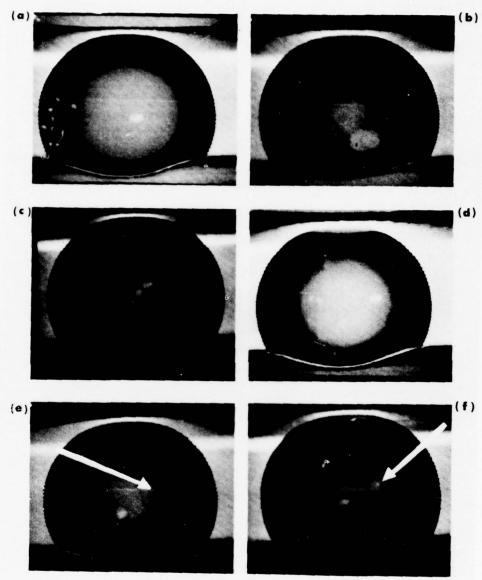
Fig. 24 - Scanning electron micrographs (30X of bearing balls. The identity of the balls vis a vis Table 20 is: (a - b) Company C, stored 10 years; (c - d) Company B, machine finished, poor; (e - f) Company B, tunble finished, poor.

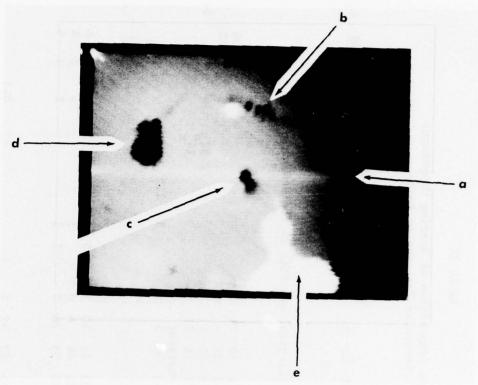
Fig. 26 - A scanning electron micrograph (100X) of the center portion of the ball in Fig. 23c. The compositions of spots a - e are given in Table 22.

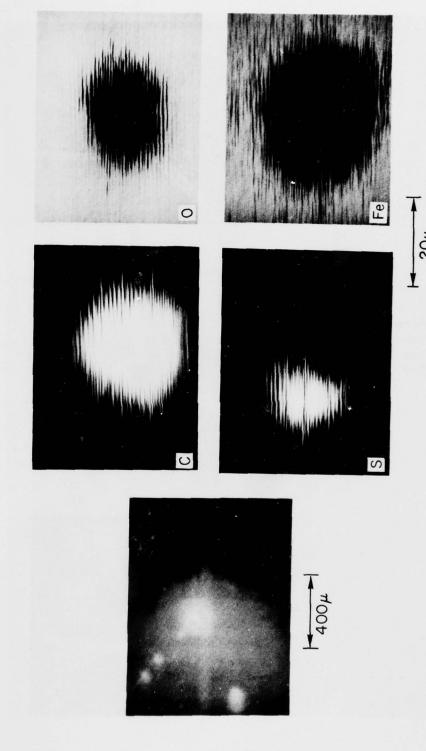
Fig. 29 - On the left, a scanning electron micrograph of the spot indicated in Fig. 24f. On the right, scanning Auger images of C, S, O and Fe. Although not shown, Al is also present in the area where the C is predominant.

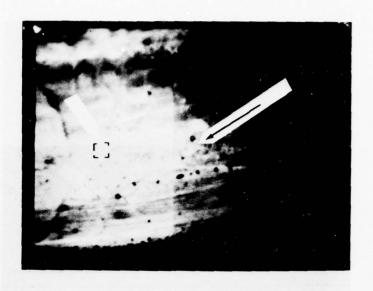
Fig. 31 - SEM micrograph (40X) of an inner race removed from an assembled bearing

The black spots on the disassembled inner races (Figs. 31 and 32) are usually associated with Ca and P deposits; this correlates with the observations on the ball (Fig. 23e and 28a) removed from an assembled bearing. The lesser defined feature seen in Fig. 33 appears to have both Ba and Ca.

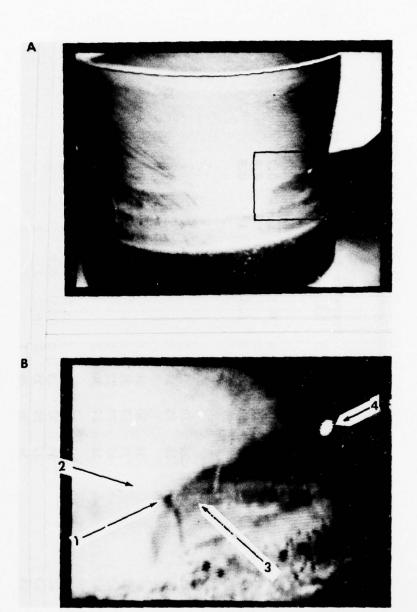
Fig. 33 - SEM micrograph of an inner race removed from an assembled bearing: (a) 12X magnification; (b) 50X magnification of the boxed area in (a).
